## **ANALYSIS OF SIDEWALL SLOPE STABILITY USING THE BISHOP METHOD AT PT BATU HITAM JAYA, JAMBI PROVINCE**

R. Saputra<sup>\*1</sup>, M. Asof<sup>2</sup>, D. Purbasari<sup>3</sup>

<sup>1-3</sup>Teknik Pertambangan dan Geologi, Fakultas Teknik, Universitas Sriwijaya

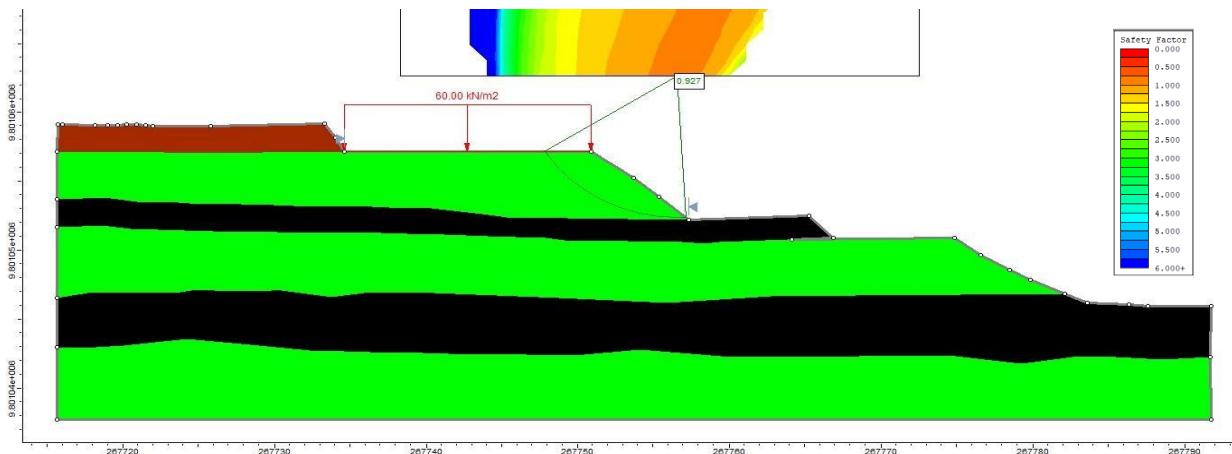
**Figure 5.** Analysis Results of the Design Existing Single Slope on Bench 2 Section A–A

Type of Slope	Slope Geometry			Safety Factor
	Height	Width	Angle	
2	5	16	38	0.927

An analysis was conducted on section A–A', which includes the overall slope and slope 2. The results of the analysis on slope 2 indicate a potential for slope failure due to a combination of weak material properties and unsafe slope geometry.

The critical slip surface was formed within the overburden clay layer, which has a low internal friction angle ( $14,76^\circ$ ) and a high unit weight ( $19,20 \text{ kN/m}^3$ ). This condition is further aggravated by the geometry of the third bench (height of 4,6 m and width of 16 m) and an additional surface load of  $60 \text{ kN/m}^2$ , which increases the shear stress on the clay layer, resulting in a factor of safety (FoS) of 0,927, indicating a near-critical condition and the value remains below the minimum stability threshold (FoS < 1.0).

Type of Slope	Slope Geometry			Safety Factor
	Height	Width	Angle	
1	1.9	7	51	
2	2	17	35	1.249
3	3	8	35	1.337
Factor of Safety (FK) of Both Redesigned Slopes				1.302

The analysis results show that the factor of safety (FK) increased to 1,302. Thus meeting the stability criteria for dynamic slopes according to Official decree from the Ministry of Energy and Mineral Resources, No. 1827 K/30/MEM/2018K/30/MEM/2018 (FK  $\geq 1.3$ ). This improvement is influenced by the adjustment of the slope geometry and the properties of the constituent materials, where the overburden material with low cohesion and low internal friction angle is the main factor contributing to potential slope failure. With the new geometry, the stress distribution becomes more uniform, enhancing the material's ability to withstand loads. Therefore, the new design for section A–A' can be recommended as a safer and more stable configuration for mining operational conditions.

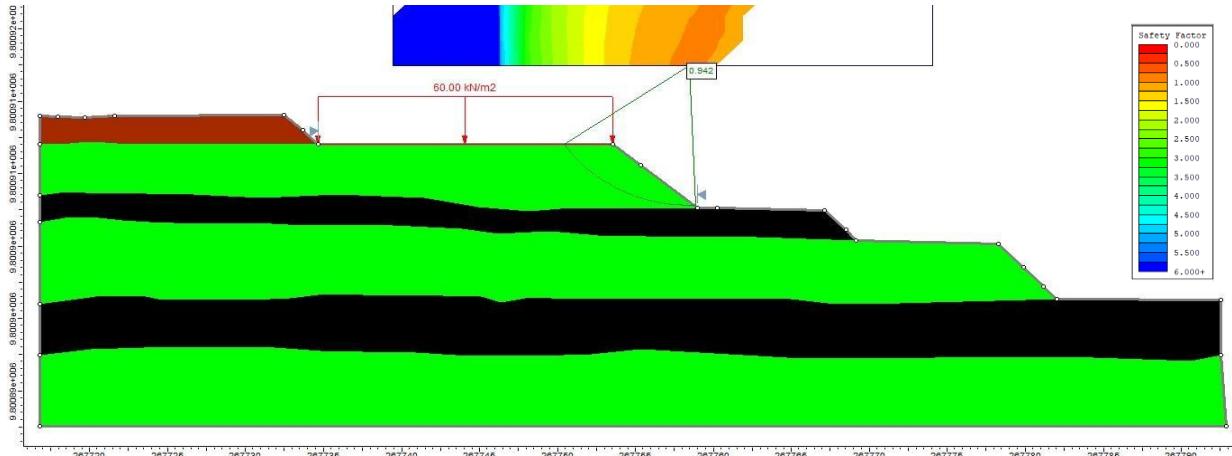
**Figure 6.** Analysis Results of the Design Existing Single Slope on Bench 2 Section B–B

Type of Slope	Slope Geometry			Safety Factor
	Height	Width	Angle	
2	4.6	16	39	0.942

A similar analysis was also carried out on section B–B', which includes slope 2. Based on the stability analysis results for slope 2, the factor of safety (FK) was found to be 0,942, which is below the minimum standard set by the Official decree from the Ministry of Energy and Mineral Resources, No. 1827 K/30/MEM/2018, requiring  $\text{FK} \geq 1,1$  for dynamic slopes.

The slope is composed of a combination of clay soil and weathered rock with low mechanical parameters. Laboratory tests yielded a cohesion ( $c$ ) of  $11,77 \text{ kPa}$ , an internal friction angle ( $\phi$ ) of  $14,76^\circ$ , and a unit weight ( $\gamma$ ) of  $19,20 \text{ kN/m}^3$ . According to the Mohr-Coulomb theory, these parameters directly influence the material's shear resistance, where low cohesion and friction angle weaken the slope's ability to resist mass movement.

Cohesion ( $c$ ) and internal friction angle ( $\phi$ ) act as resisting forces along the slip surface, while the unit weight ( $\gamma$ ) increases the driving forces. In this case, the combination of low resisting forces and high driving forces creates an unbalanced force ratio, resulting in a factor of safety (FK) less 1.

The analysis results show that the factor of safety increased to 1,244, which meets the criteria set by Official decree from the Ministry of Energy and Mineral Resources, No. 1827 K/30/MEM/2018 for dynamic slopes (FoS  $\geq 1.1$ ). This improvement was achieved because dividing the critical slope into two benches

Type of Slope	Slope Geometry			Safety Factor
	Height	Width	Angle	
1	1.9	7	51	
2	2	16	35	1.222
3	2.6	8	35	1.443
Factor of Safety (FK) of Both Redesigned Slopes				1.244

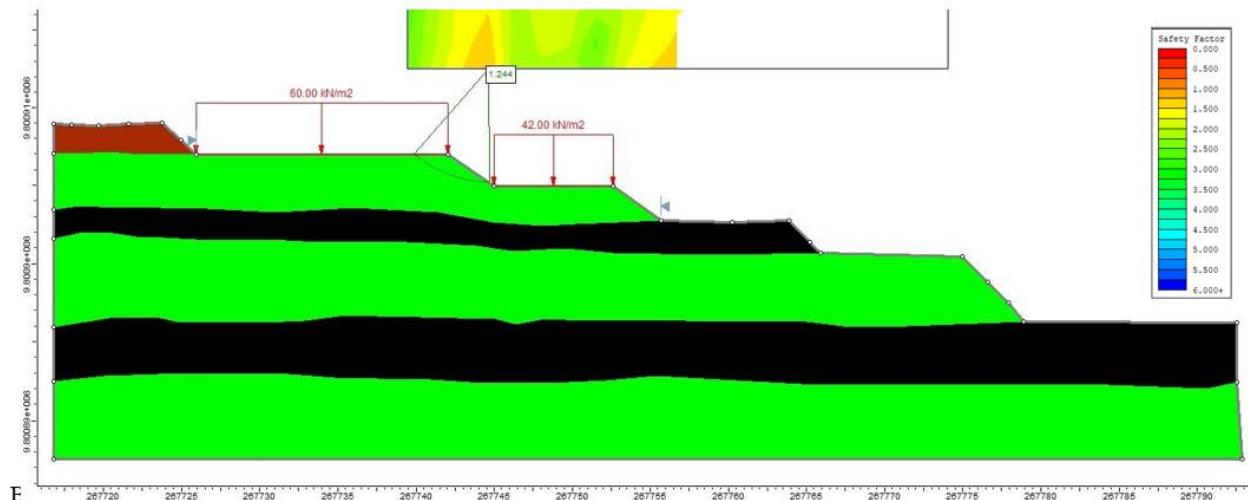
**Figure 12.** Analysis Results of the Redesign Existing Single Slope on Section B-B'

successfully reduced the load on a single large slip surface, while combining the upper benches helped decrease stress concentration at the crest area.

For section B–B' recommended slope design for section B– B' can be seen in (Figure 10), (Figure 11), and (figure 12), the improvement in the factor of safety focused on the slope geometry, including slope height, width, and inclination angle. The recommended slope geometry can be seen in (Table 5).
