## **ANALYSIS OF SIDEWALL SLOPE STABILITY USING THE BISHOP METHOD AT PT BATU HITAM JAYA, JAMBI PROVINCE**

R. Saputra<sup>\*1</sup>, M. Asof<sup>2</sup>, D. Purbasari<sup>3</sup>

<sup>1-3</sup>Teknik Pertambangan dan Geologi, Fakultas Teknik, Universitas Sriwijaya

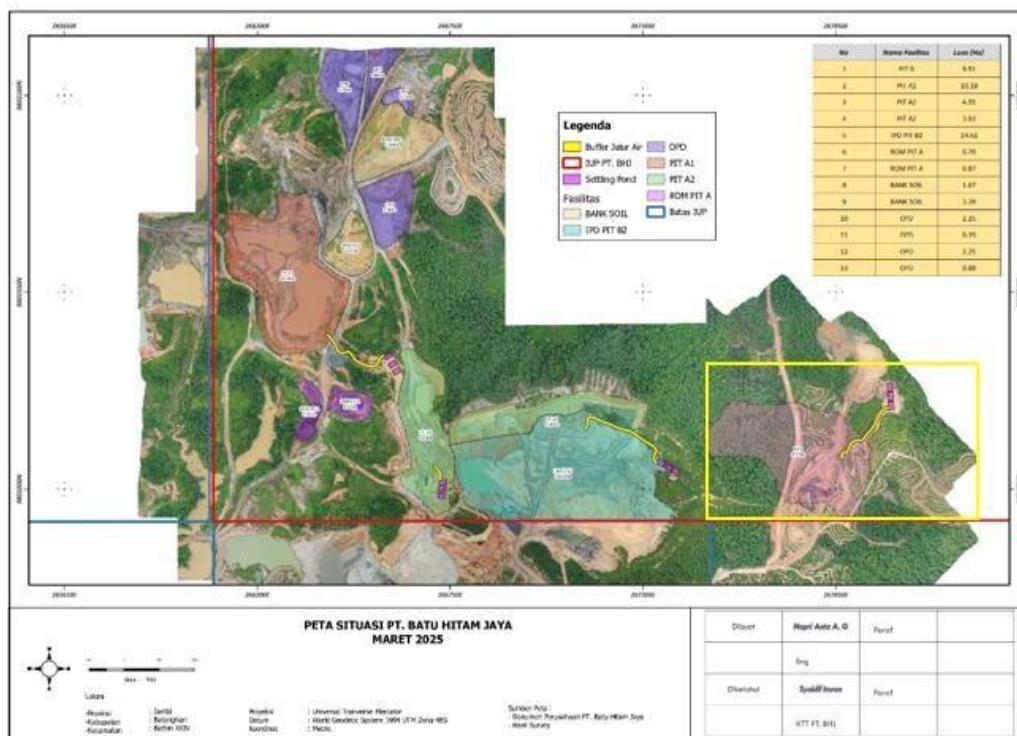
**Figure 3.** Pit B2 Mine Situation Map

Pit B2 is one of the coal mining areas located in the southeastern part of PT Batu Hitam Jaya's concession area. Geographically, this pit is situated at the lower right section of the company's site map, with its boundaries clearly marked by a polygon line. The area is surrounded by vegetation cover on the outer side of the concession, while the inner section has been designated as a production zone for coal mining activities. A clearer illustration of the location can be seen in (Figure 3).

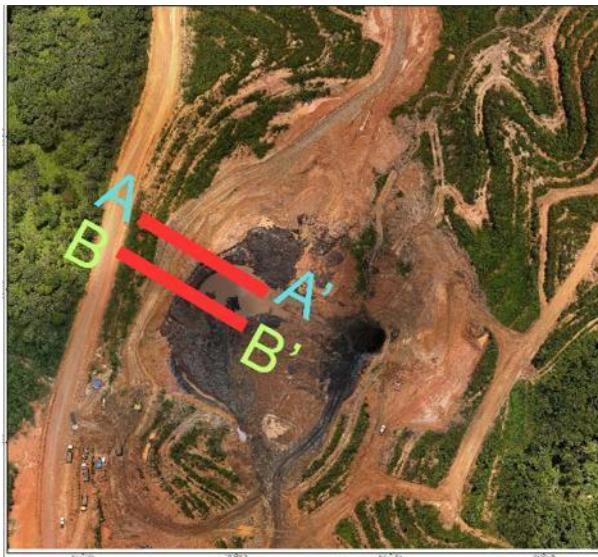
Figure 4. Cross Section Location

The cross-section lines A–A' and B–B' were selected to pass through areas with significant elevation differences, allowing the slope geometry to be illustrated more clearly. These cross-sections are used to evaluate the slope angle, bench height, and overall slope inclination to ensure they comply with the established geotechnical recommendations. Moreover, this analysis is essential to ensure the stability of the sidewall throughout the mining process. With the selection of cross-section lines A–A' and B–B', the slope characteristics can be analyzed more accurately for design and safety assessment purposes.
